The Effect of Structures and Lake Level on Bluff and Shore Erosion in Berrien County, Michigan, 1970-74

by
William A. Birkemeier

**MISCELLANEOUS REPORT NO. 80-2
APRIL 1980**

**U.S. ARMY, CORPS OF ENGINEERS
COASTAL ENGINEERING
RESEARCH CENTER**

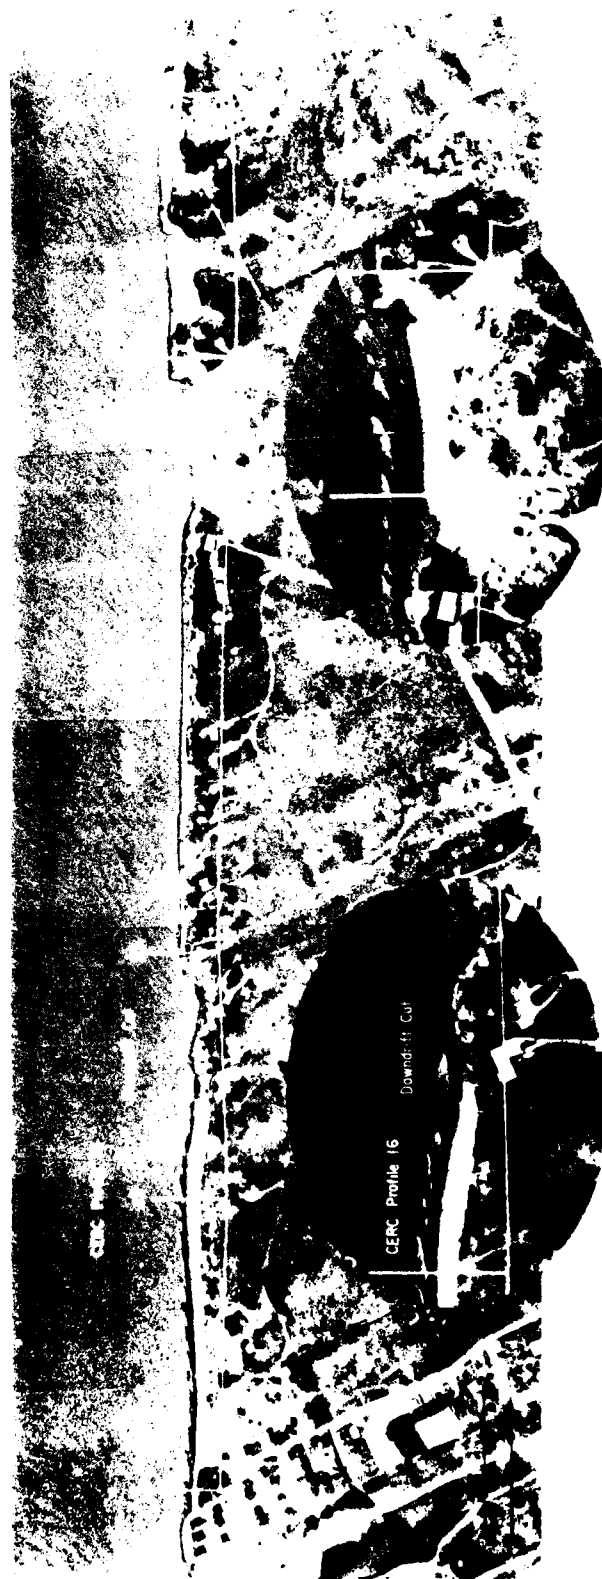
Figure 9. Composite aerial photo taken 23 November 1974 showing reach B with main sections identified. Inlets show details of dune and downdrift cut; arrows identify shore protection structures.

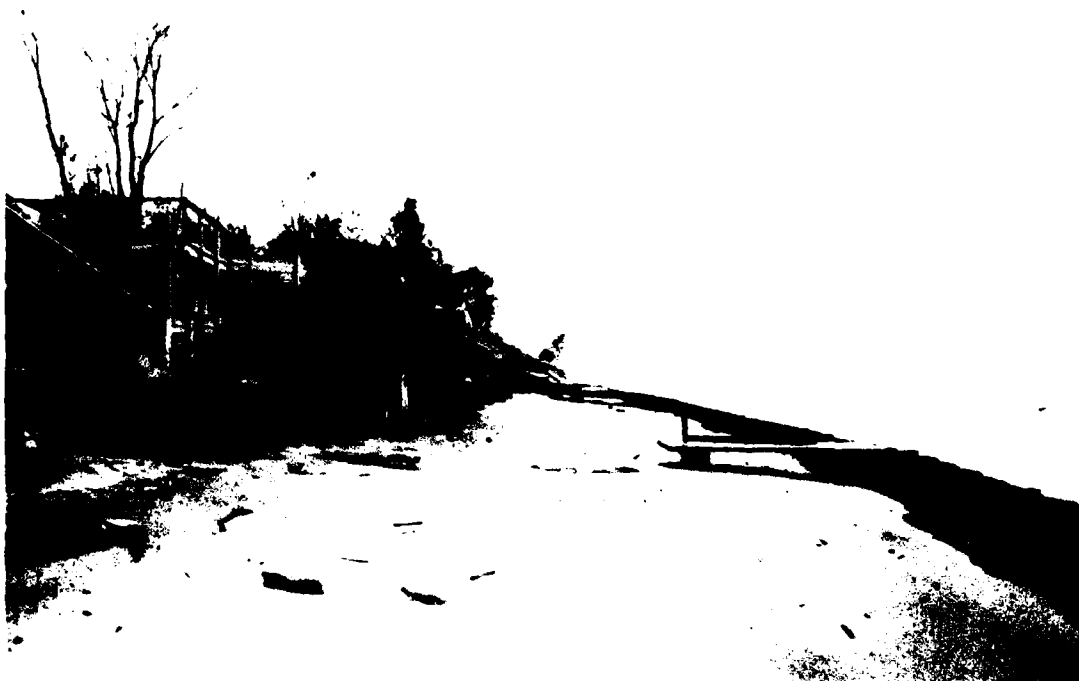
Figure 11. View southward from station 28 along the seawall (16 October 1976).

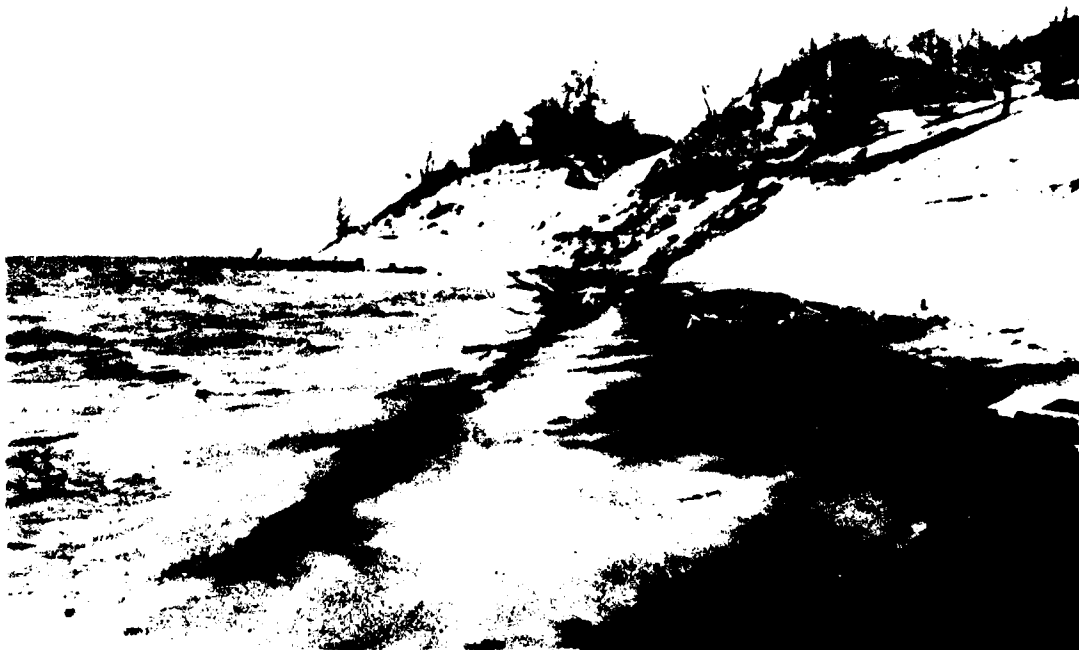
Figure 12. View northward from station 42 showing the dune section north of the seawall (16 October 1976).

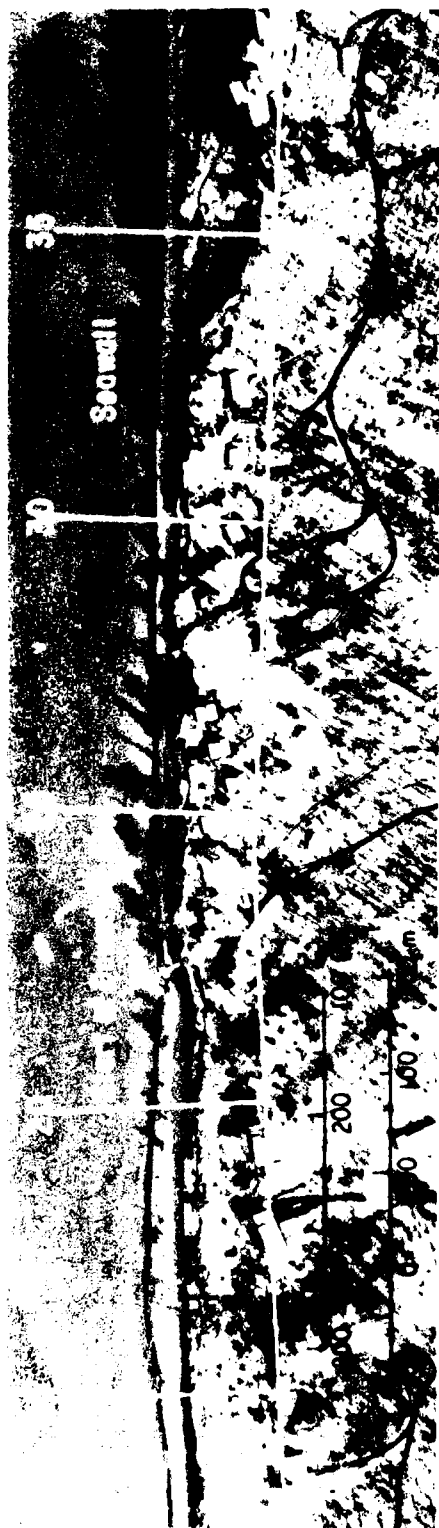
Figure 15. Aerial photos showing development of the down-drift cut south of the seawall from 16 November 1972 (top) to 20 November 1973 (bottom). See Figure 9 for November 1974 condition.

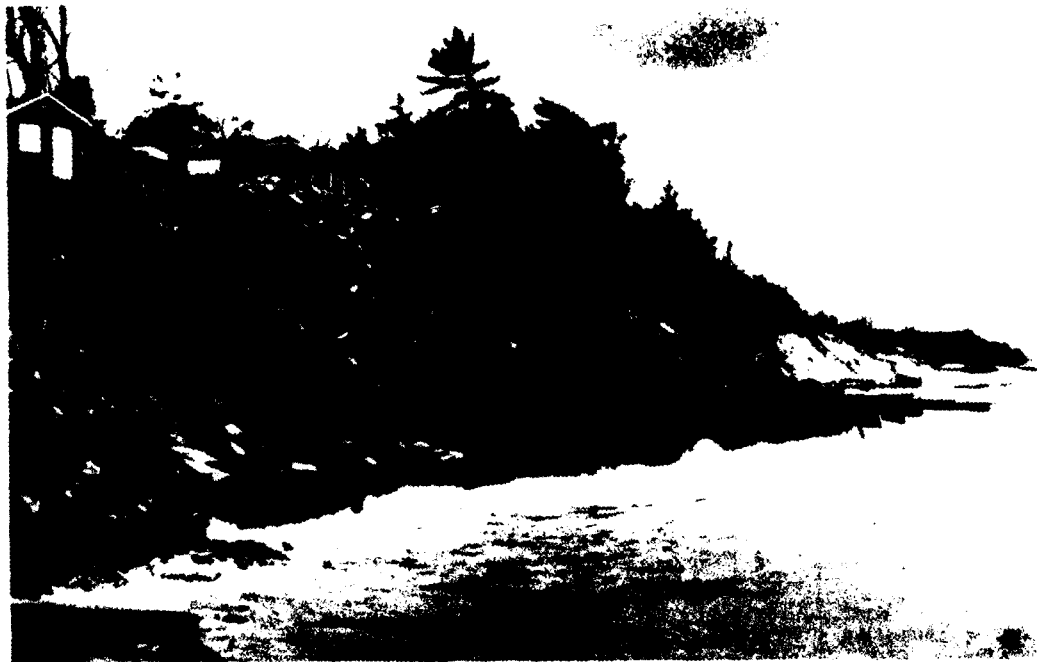
Figure 17. View of the downdrift cut from the southern end of the seawall. Heavy vegetation on the bluff slope indicates successful stabilization (16 October 1976).

The downdrift erosion has continued; however, an October 1976 field visit found the bluff slope in the cut area well vegetated and stabilized (Fig. 17) and the bluff at CERC profile line 16 stabilized by the installation of a pre-cast concrete seawall (Fig. 18). Measurements at CERC profile line 16 indicated an additional 9 meters of recession since November 1974. The bluff

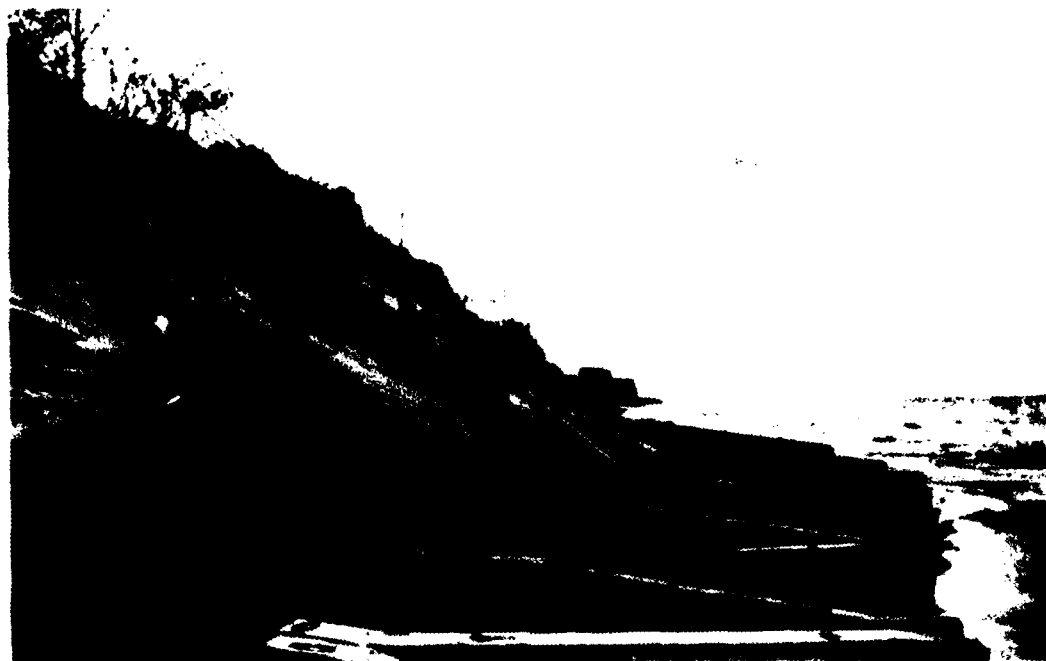
Figure 18. Bluff at CERC profile line 16 recently stabilized by precast-concrete seawall following a period of severe erosion (16 October 1976).

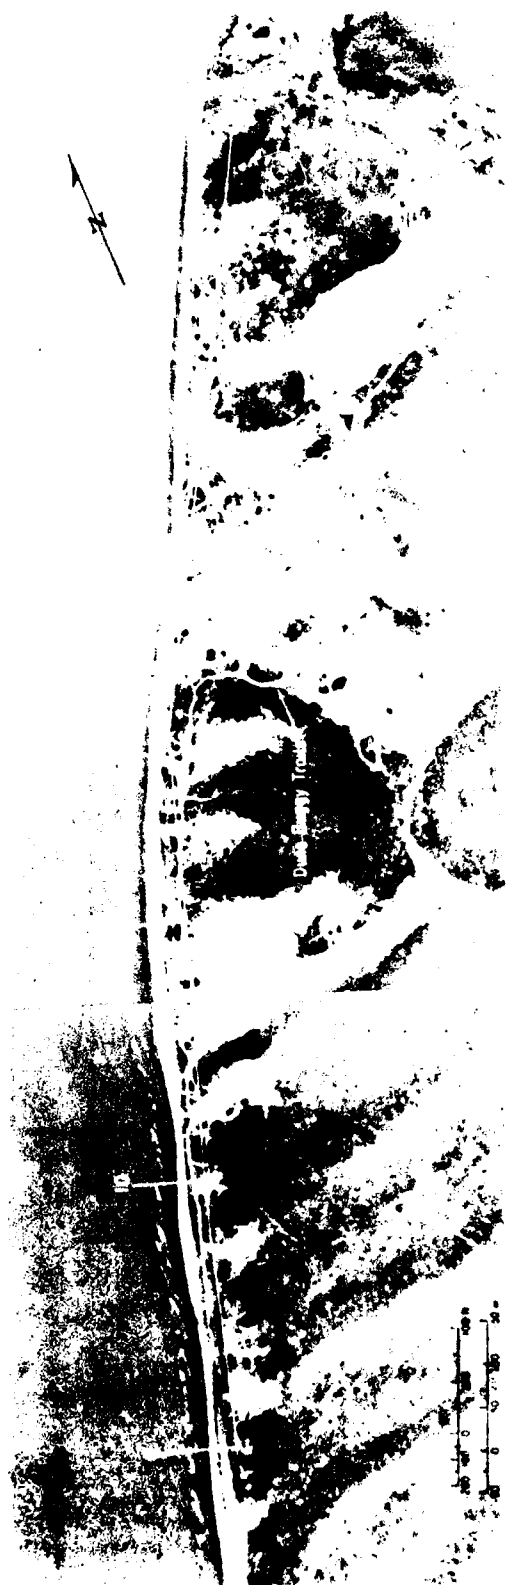
Figure 20. Composite aerial photo of reach C taken 23 November 1974.
Note dune buggy trails between stations 30 and 40.

Only reach C of the five reaches showed any lakeward movement of the bluff line due to foredune accretion. All of the accretion occurred south of the bend in the orientation of the shoreline between stations 20 and 30 (see Fig. 20).

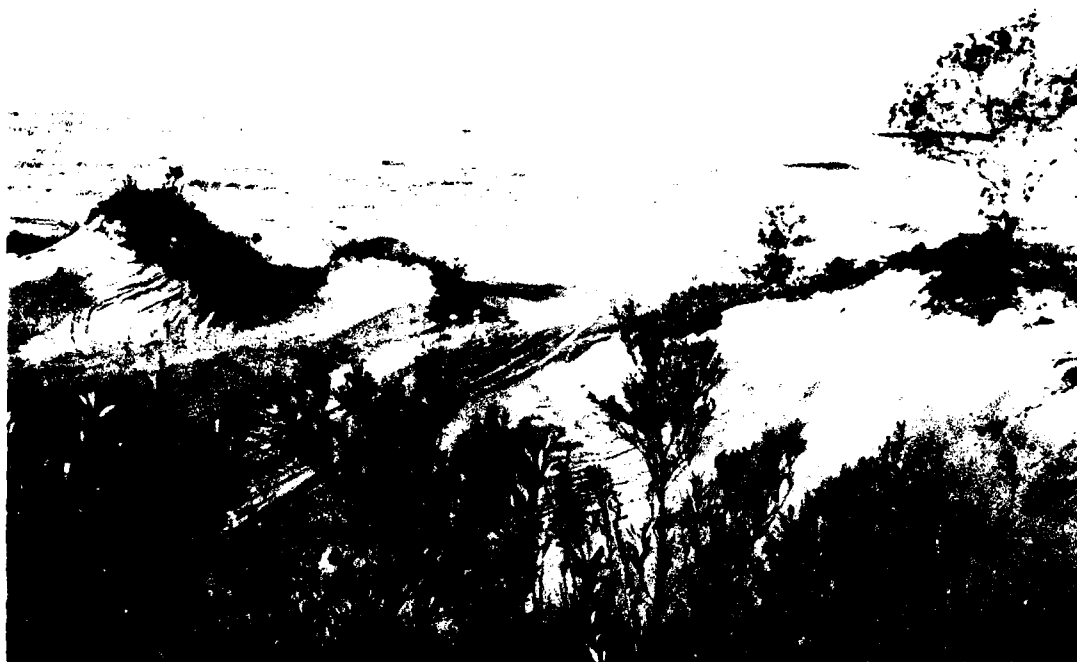
Figure 21. Low foredune topography typical of reach C (17 October 1976).
